Re: 1111 New Home Street

Inspection Report

All Pro Home Inspections

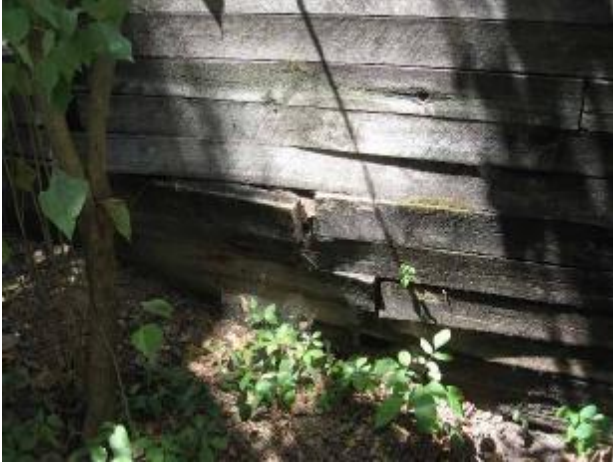
GD1

The retaining wall located adjacent to the house at the SW corner is decayed and failing (see photos). This is a wood timbered retaining wall that is a relatively long wall that will be expensive to replace. I recommend that you contact a contractor for further evaluation of this wall. Obtain estimates and replace as needed.

Decayed retaining wall at South side

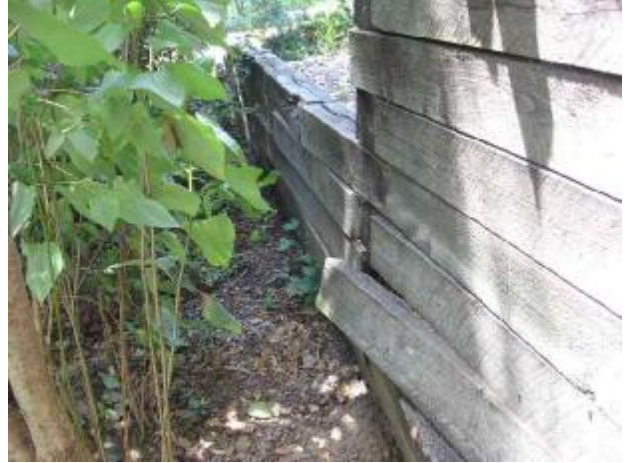
GD2

Decayed retaining wall

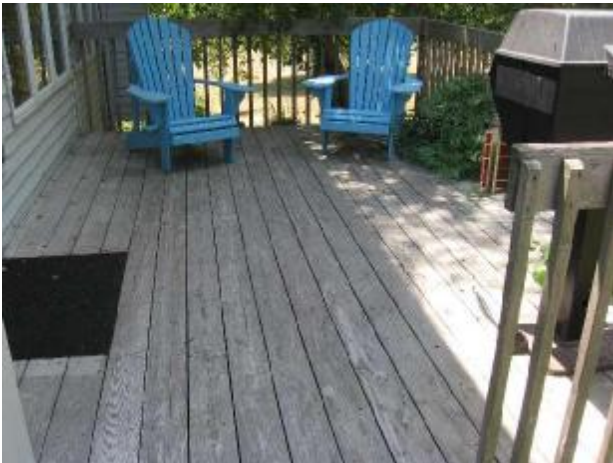
GD3

This deck is constructed of wood. As a wood product (even treated wood), the deck should periodically be cleaned and stained or otherwise sealed to prevent excess weathering of the wood. Typically this wood should be maintained every 2-3 years to maintain its new look. Depending on your skill level, this is usually performed by the home owner or it can be done by a company that specializes in deck maintenance. Check with your local hardware or building supplier for specific recommendations on maintenance of your deck. Deck is generally weathered and has not been recently maintained. Power wash, stain and seal deck within the next couple of years as a normal maintenance item (see photo).

Power wash, stain and seal deck

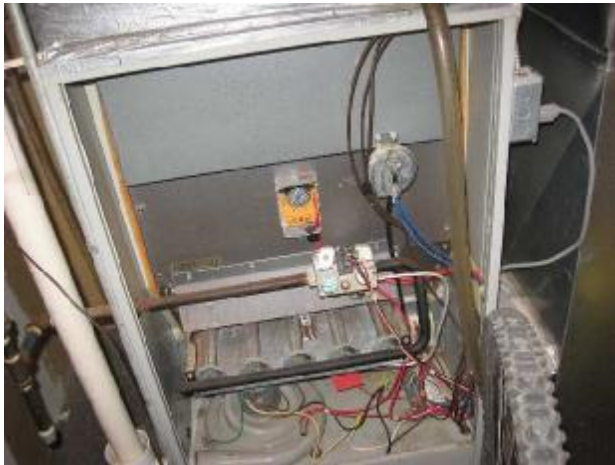
HC3

Keep in mind the advanced age of this heating unit. Although it is operational it is approaching the end of its normal life span. Consider placing this unit on a budget for replacement.

Furnace

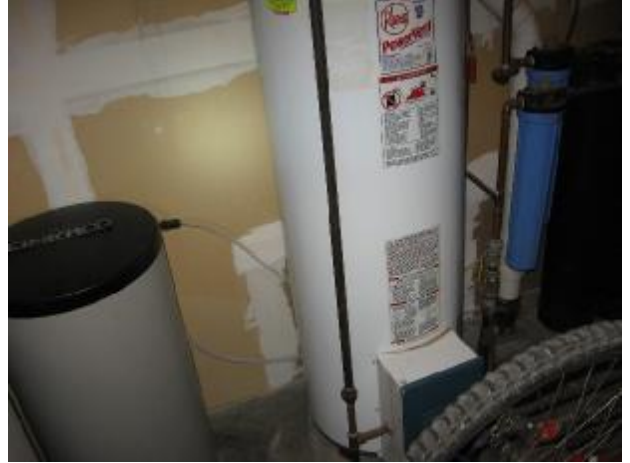
P2

Keep in mind the advanced age of this water heater. The unit is beyond its normal service life and its remaining life before failure can not be predicted. Consider replacement of the water heater before it fails.

Water heater

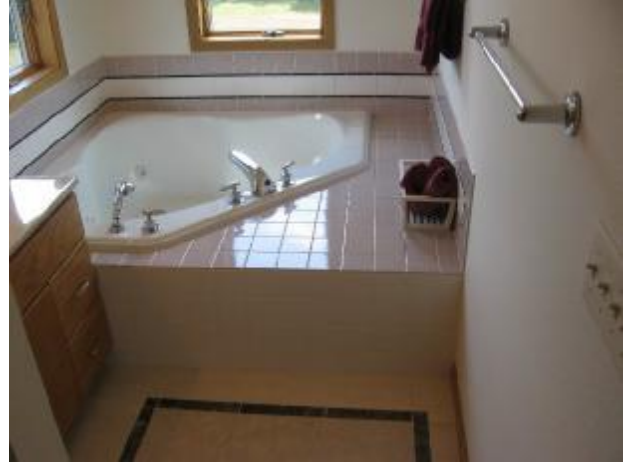
B2

- 14 There is no access panel for the whirlpool bath. This means that the pump and plumbing can not be visually inspected or repaired without removal of tile or cutting a hole through the wall. Installation of an access panel is always recommended before using the whirlpool.

Whirlpool

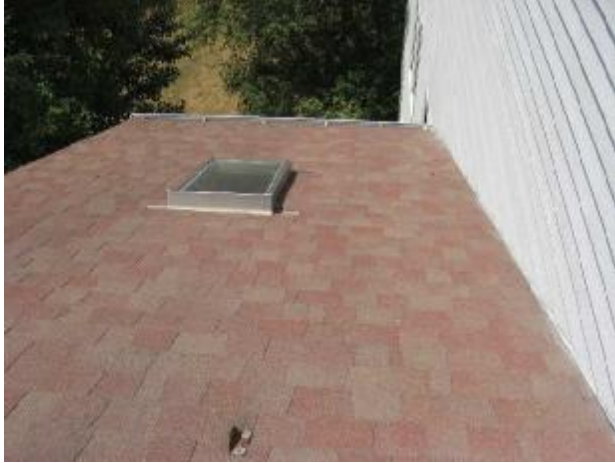
IR1

There is some staining at the top and in the window well of the skylight located in the South second floor porch area. It appears that there has been more than one event of leakage, but has not repeatedly leaked. Possible sources are the gasket around the top frame of the skylight or around the flashing. Have a roofer evaluate and replace the gasket or repair the flashing as needed. Ask the owner about past history of any leakage (see photos).

Skylight over screened porch

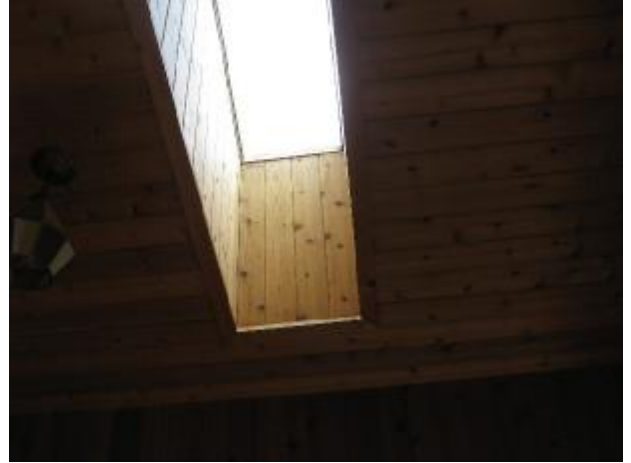
IR2

Stains around skylight

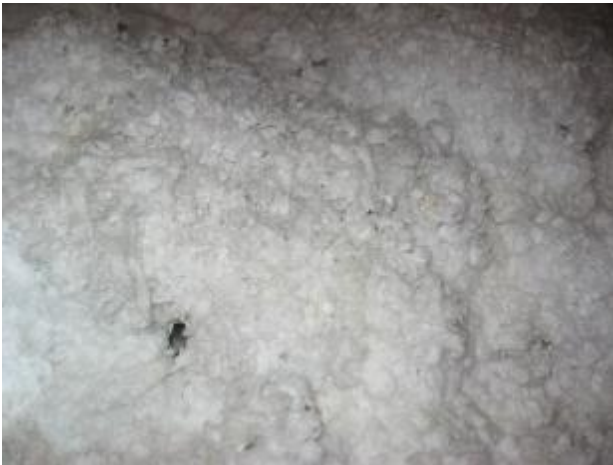
AT3

Note past mouse problem
